The Prevalence and Costs of Scour Damage at River Bridges in South Africa

M.E. Cunningham¹, N.P. Armitage²

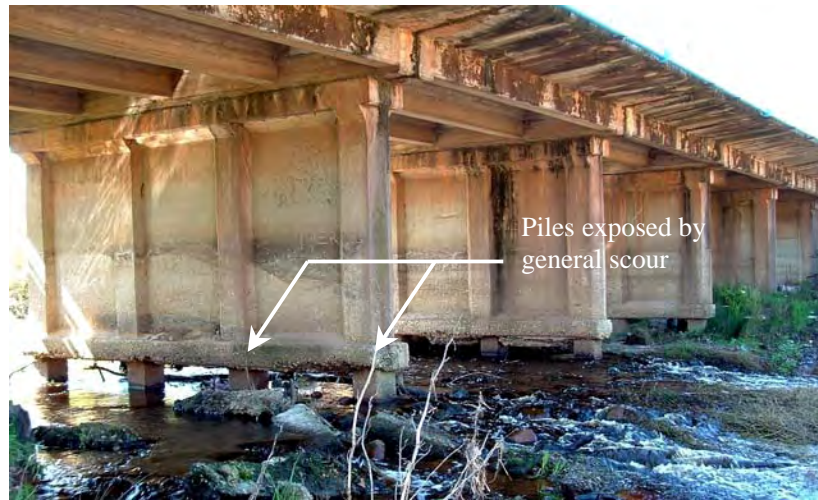
General scour was observed at 20% of the 105 bridges analysed. It is often a natural process but may be accelerated by mining of the riverbed. Figure 2 shows a bridge where general scour has exposed piles now subject to local scouring.

Figure 2: General scour has exposed pile foundations in the Palmiet River in the main street of Grabouw, Western Cape.

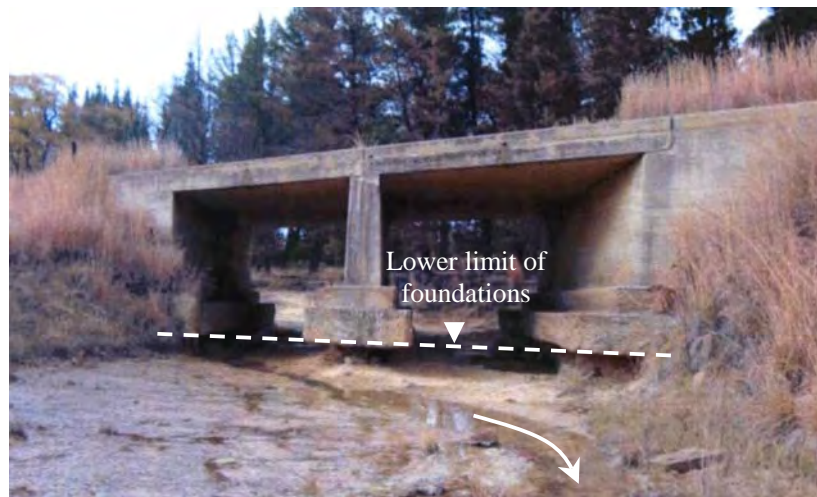
Constriction scour was evident at 44% of the bridges studied and was typically characterised by a lowered riverbed under the bridge and immediately downstream (Figure 3). In some cases, scour caused by constriction was evident for a significant distance downstream. Constriction is also linked to outflanking as a narrow opening will cause excessive afflux, overtopping and erosion of the approach fill. Water which exits a constriction at a high velocity may also cause local scour as backflow occurs against the downstream abutments. Scour at man-made river constrictions aggravates sediment deposition on agricultural land, in dams and on human settlements downstream as occurred in Laingsburg in 1981.

**Figure 3: The bridge above is in a critical state as constriction scour has eroded the riverbed under and downstream of the structure, exposing the foundations completely. The foundations rest only on small amounts of directly-compressed material.
(Photo: Free State Department of Transport)**

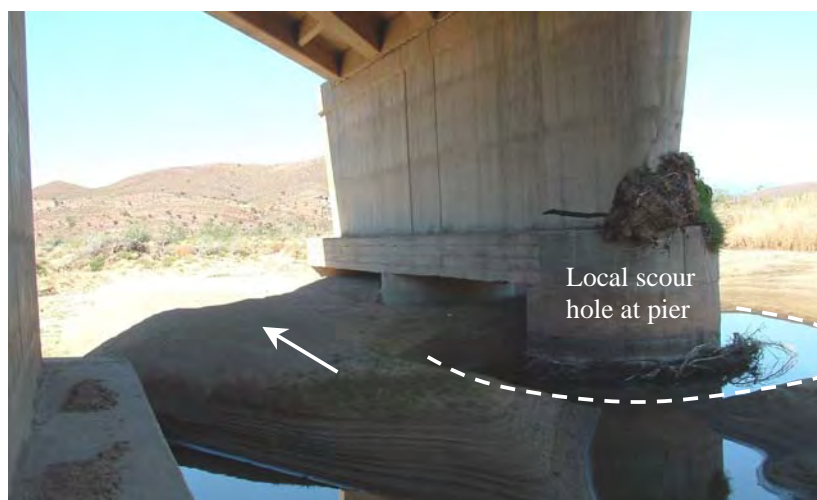
Local scour at piers and abutments was found at 60 % of the surveyed sites and was the most prevalent type of scouring identified. Local scour is not usually visible, particularly under flood conditions. Scour holes may also be concealed by turbid water and vegetation which has grown in stagnant pools under bridges. When the field survey was undertaken during July 2004, the east coast and interior of South Africa were experiencing a dry season. Evidence of local scouring could thus be observed in several dry riverbeds (Figure 4) and in shallow, clear water. Local and constriction scour were found to occur simultaneously at 37% of sites. Local scour was observed at piers and at the upstream sides of several abutments where the oncoming flow was not aligned with the bridge openings.

Figure 4: Local scour hole at the Touw River bridge between Ladismith and Riversdale, Western Cape.

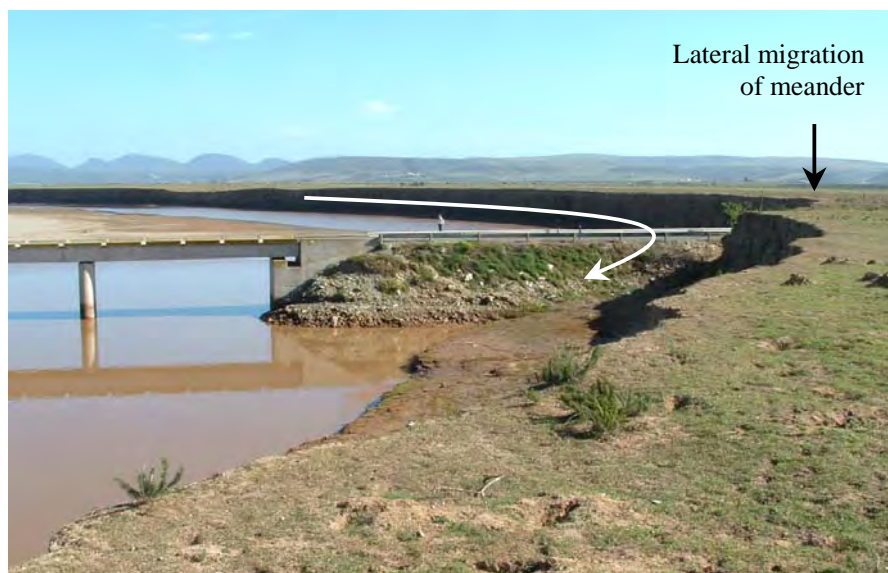
Outflanking of bridges and weirs was not the focus of this investigation but is linked to constriction scour as constriction causes afflux which may overtop earth embankments. Figure 5 shows a bridge which is likely to be outflanked due to lateral migration of the meander on which it is situated.

Figure 5: Lateral erosion on this meander of the Gouritz River, Western Cape, has shifted the natural river bank quite some distance beyond the bridge abutment. The bridge is in danger of being outflanked in future floods.
